## Research on the British and German Prototypes

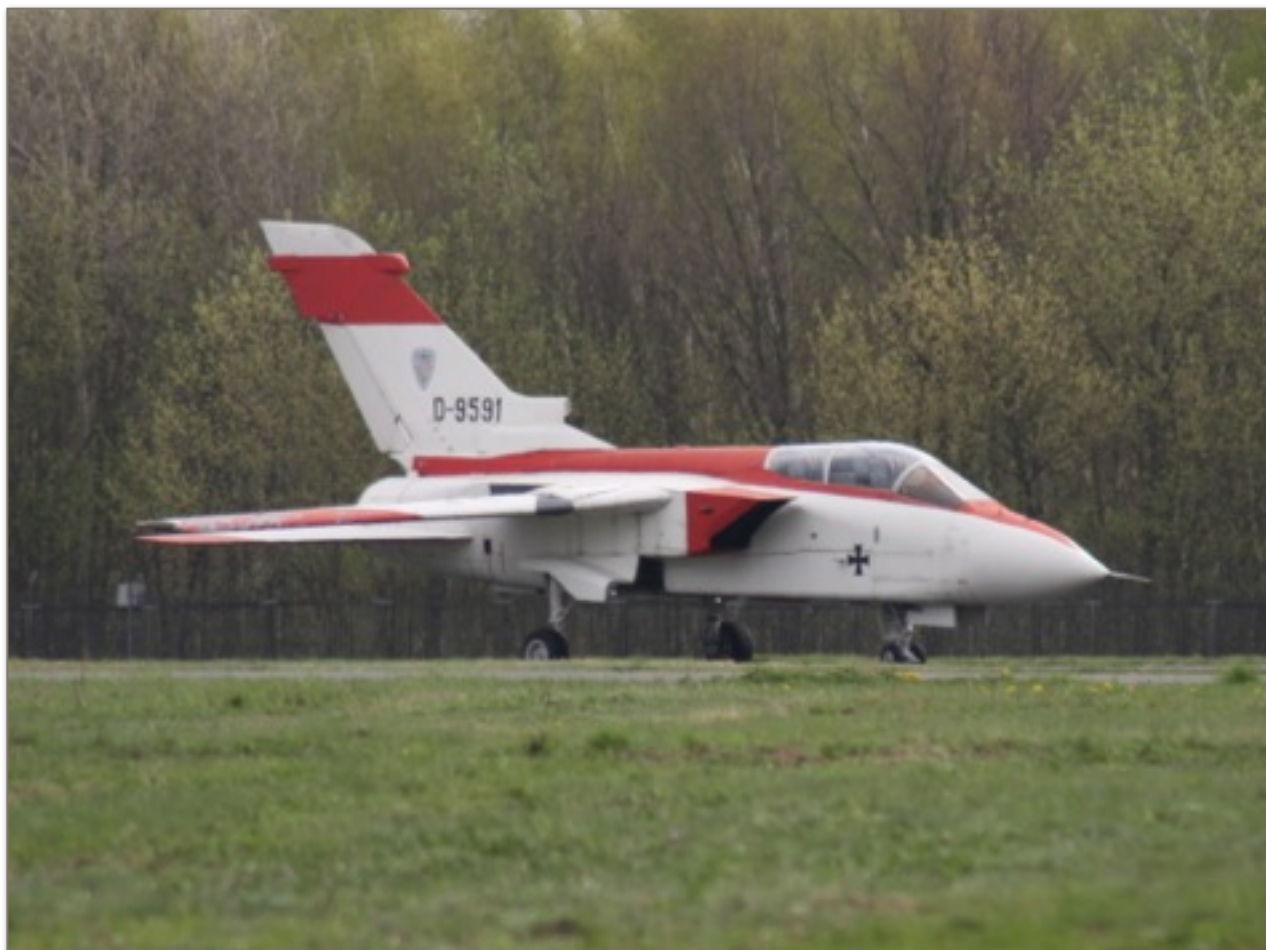
D-9591 has been in open storage at the Luftwaffe Museum at Gatow near Berlin for the past year. It is not on general display. The scheme is not authentic.

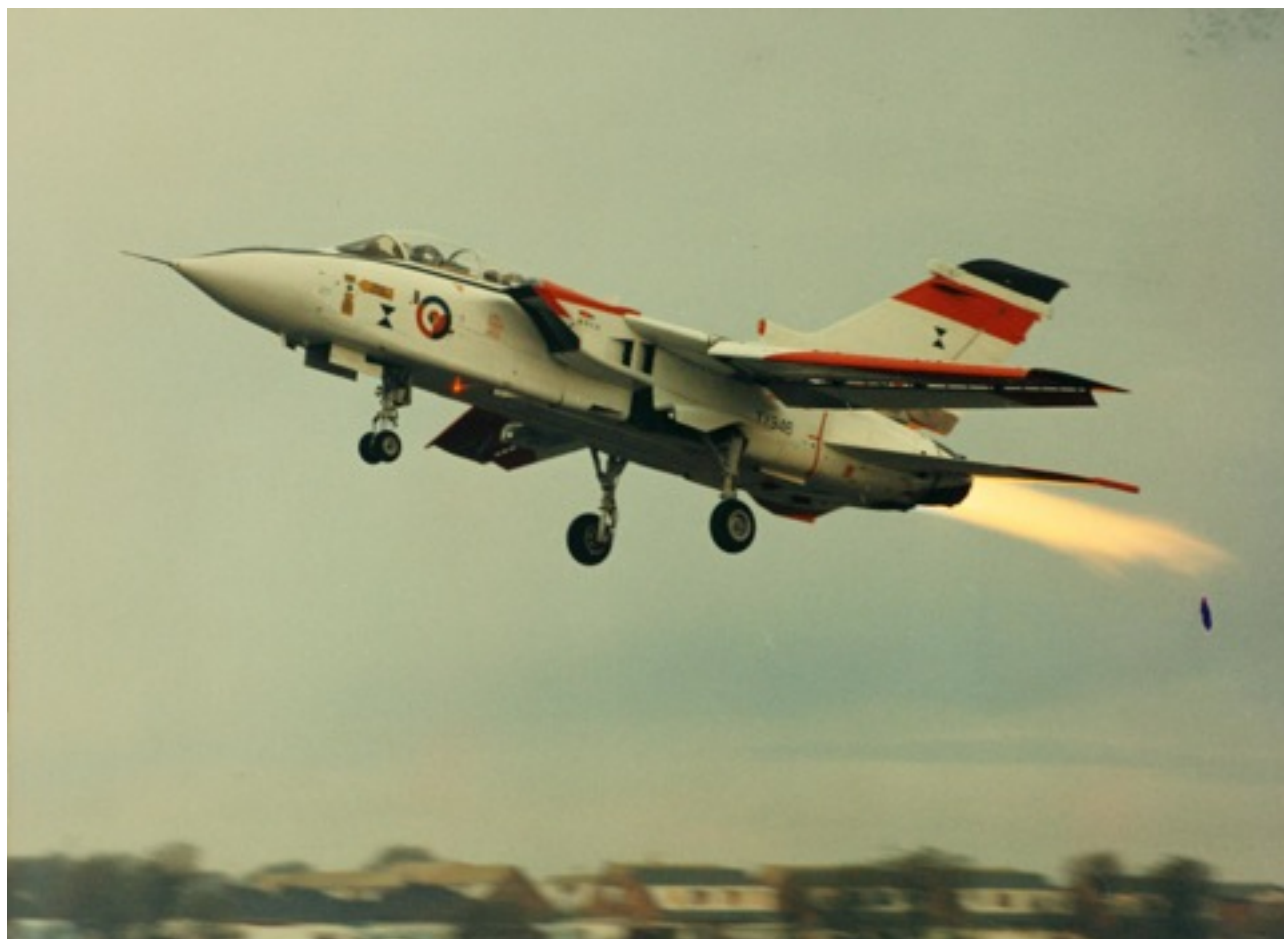
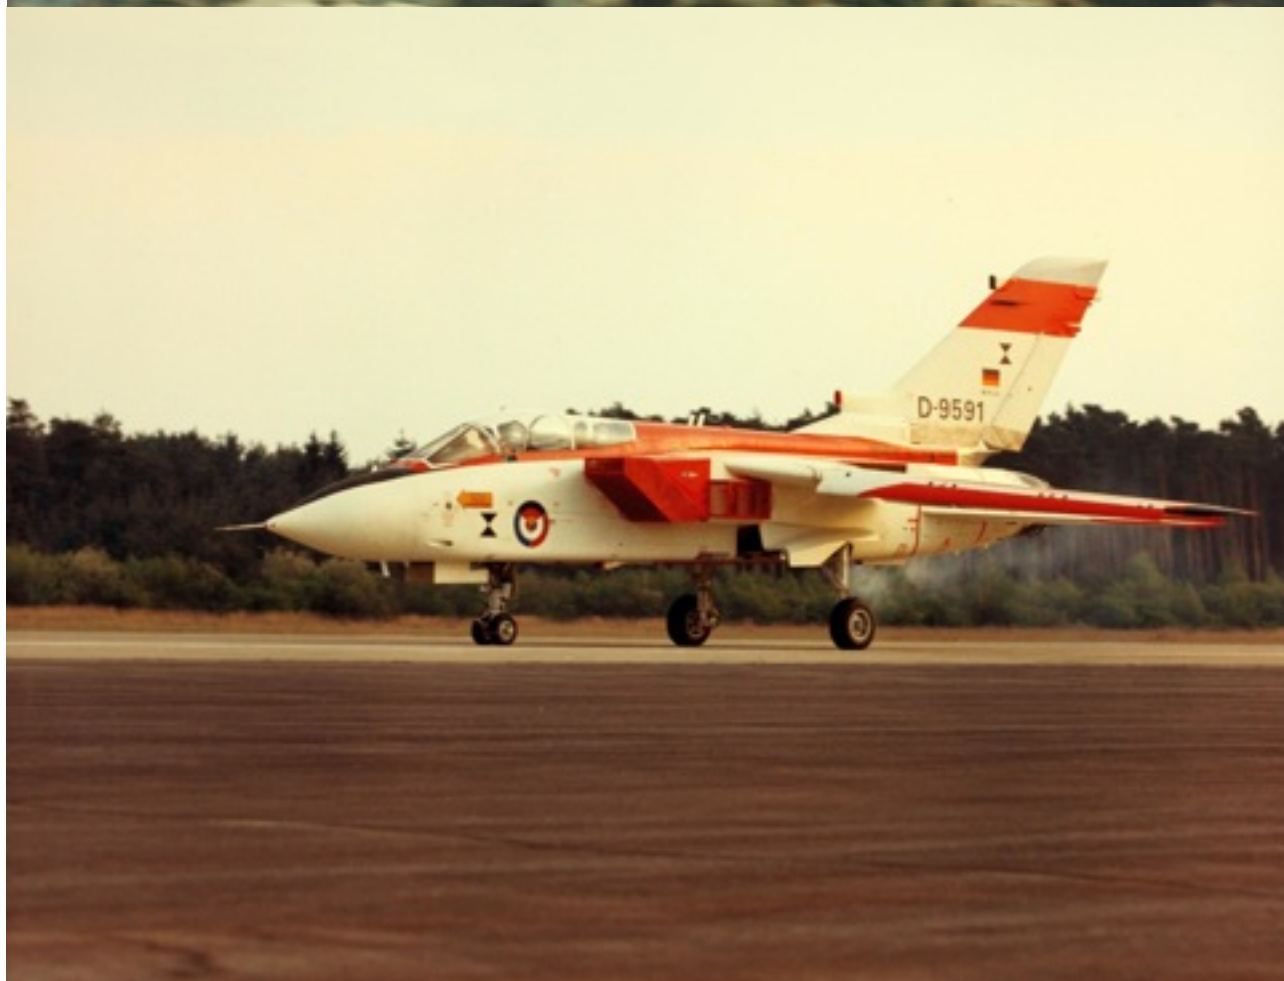
With the exception of marking on the nose, stencils follow the standard early Tornado pattern. The photographs on P.01 and P.02 on the next page give a reasonable idea of how the stencils appear on the delivery schemes.

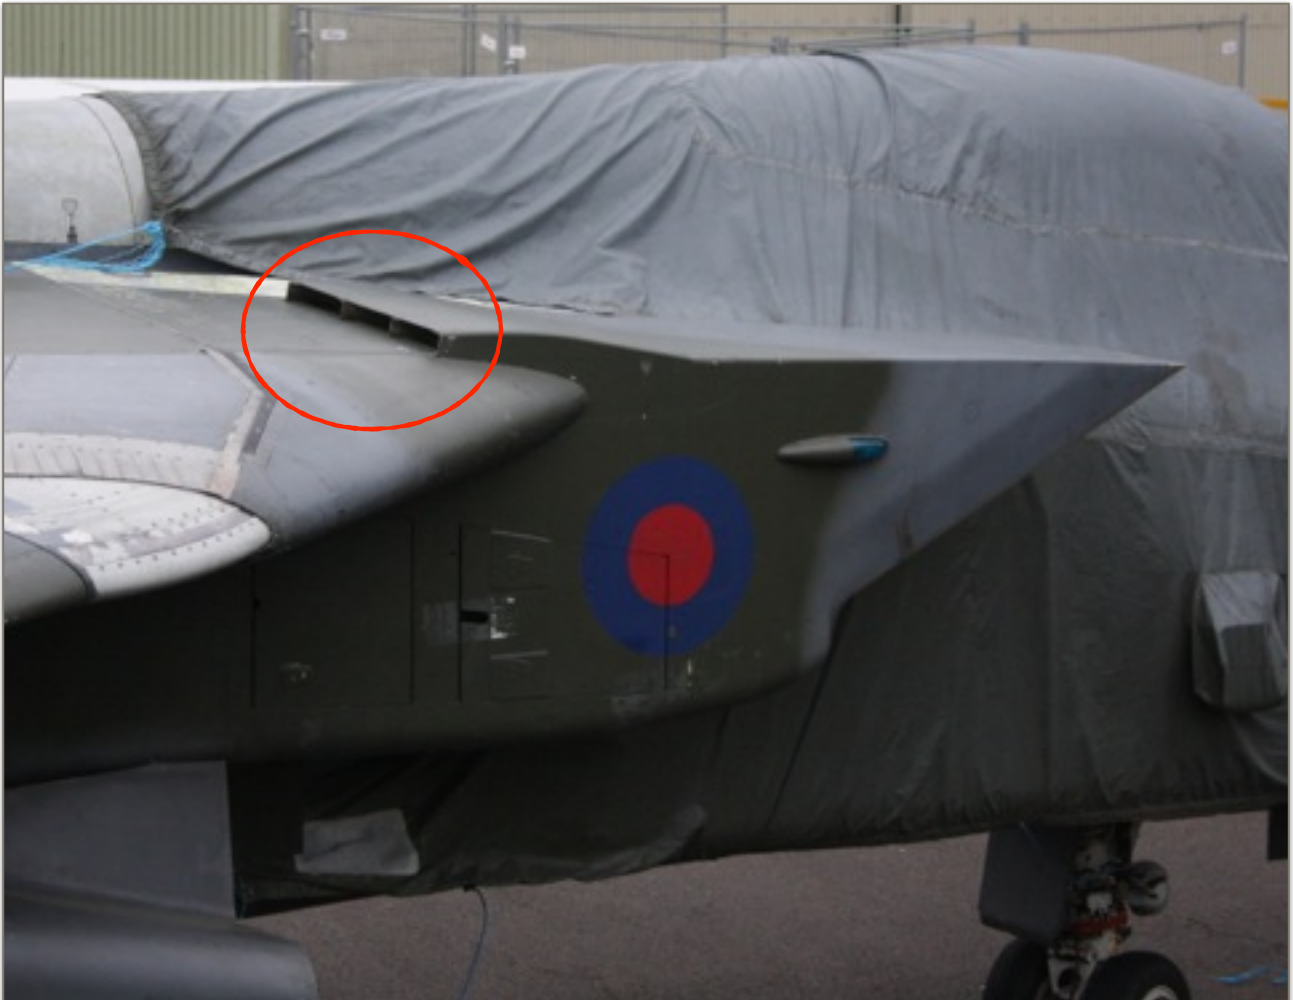
## Intake Modifications

The Intakes of P.01 and P.02 are different, and they both differ greatly from the standard Tornado. Starting with P.02, the photograph below shows a distinct hump. D-9591 did not have this hump, the rear of the intake was flush the fuselage.

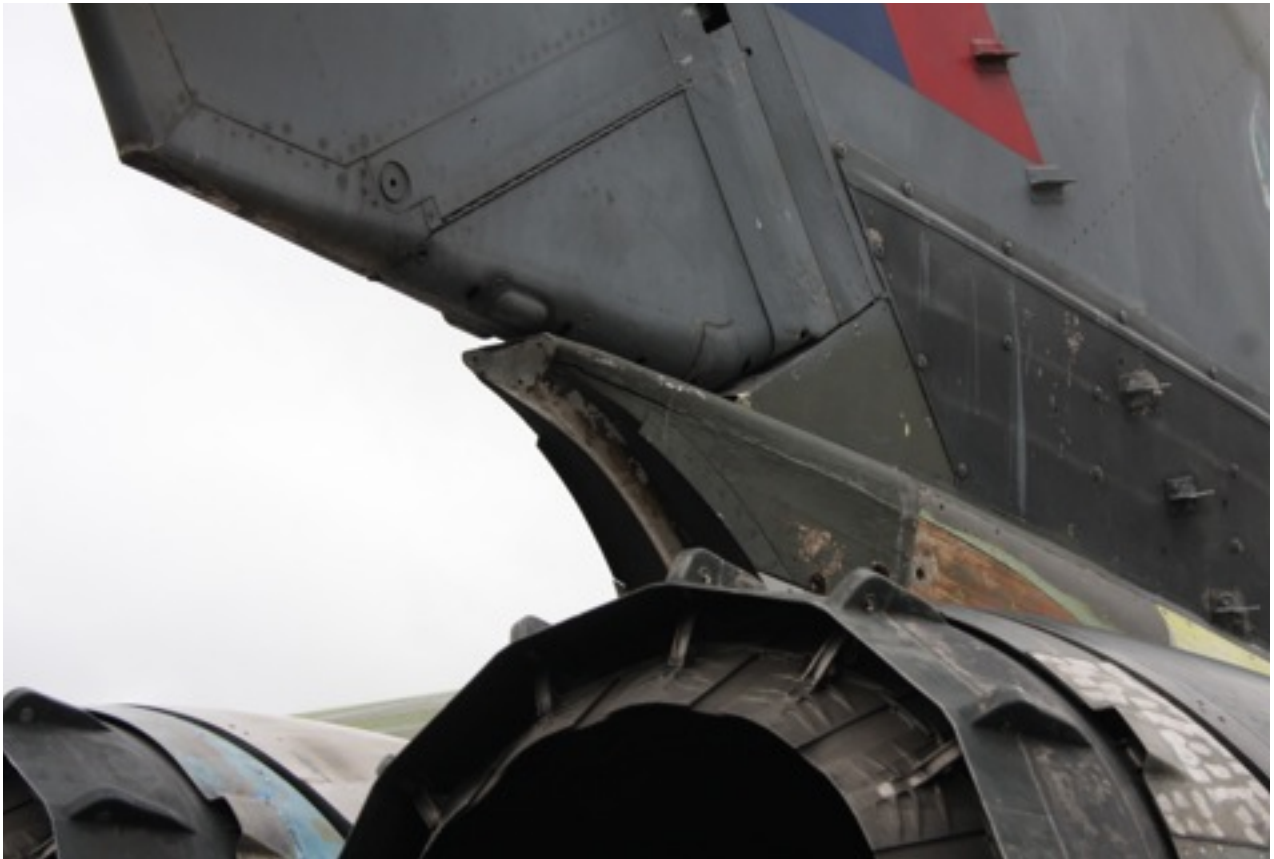
## Tail Modifications

The photographs below show the difference (from a standard Tornado) below the rudder on P.02. It is also representative of P.01. On the following pages other differences from the standard Tornado have been highlighted. P.02 seems to be missing the rear tip of its tail and in these pictures it is fitted with a tail mounted camera (something not fitted on its maiden flight).
